MICHAUD engineering

Residential Building Inspection Report

123 Fourth Street

Date: 7/5/06

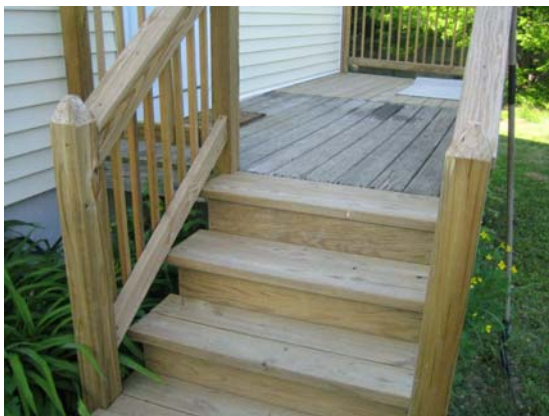
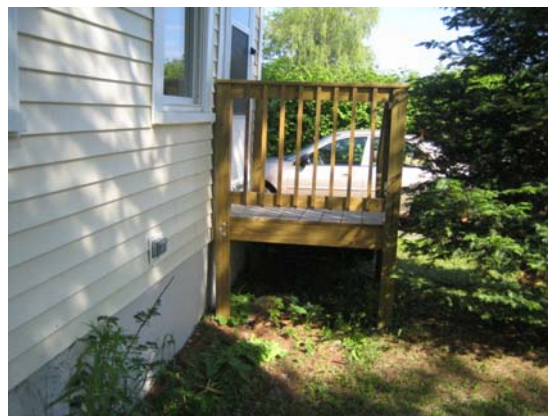
5.2 WALKWAYS AND EXTERIOR STAIRS:

There is a gravel walkway that leads from the driveway to the front and side steps and entrances. The walkway is level and is in good repair. The steps to the front entrance are pressure treated wood and in good repair, and appears to be part of the recent upgrades. The side deck is a mix of existing and new pressure treated lumber. Both the new and existing portions of the deck appear to be in good repair and sound condition.

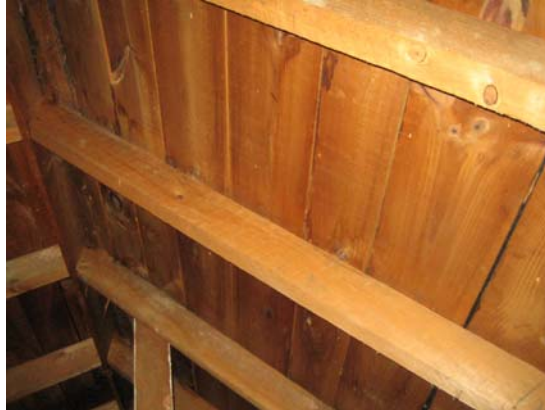
6.3 ROOF FRAMING:

The portions of the roof that were visible showed that 2"x6" full dimension lumber on 20" centers was used to construct the roof truss system. The roof deck is 1"x6" and 1"x8" full dimension planks. There was no evidence of sagging or broken truss members.

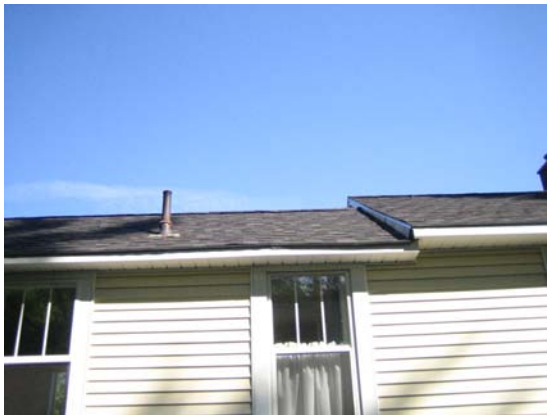
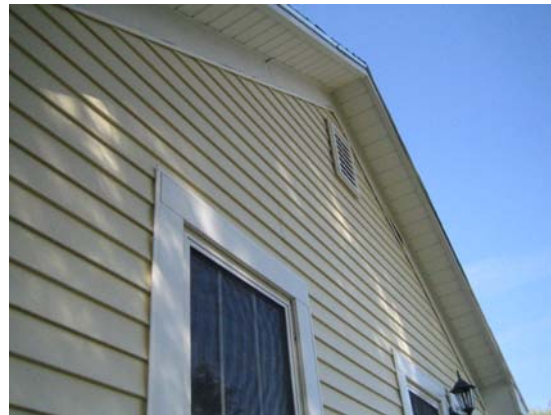
The roof employs both ridge and gable vents for ventilation. Access to the attic space was limited, and it was not clear if the soffit vents were correctly opened for proper air flow. The ridge and gable vents should provide sufficient ventilation for the attic.

Note: If further insulation is added to the attic, care should be taken not to cover the soffit vents.

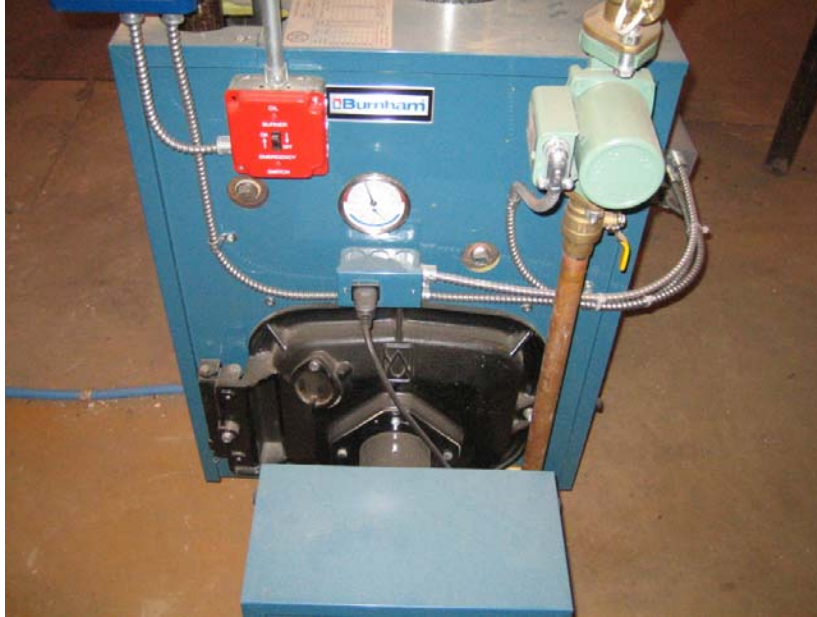
The primary heat source for this dwelling is a HWBB system.

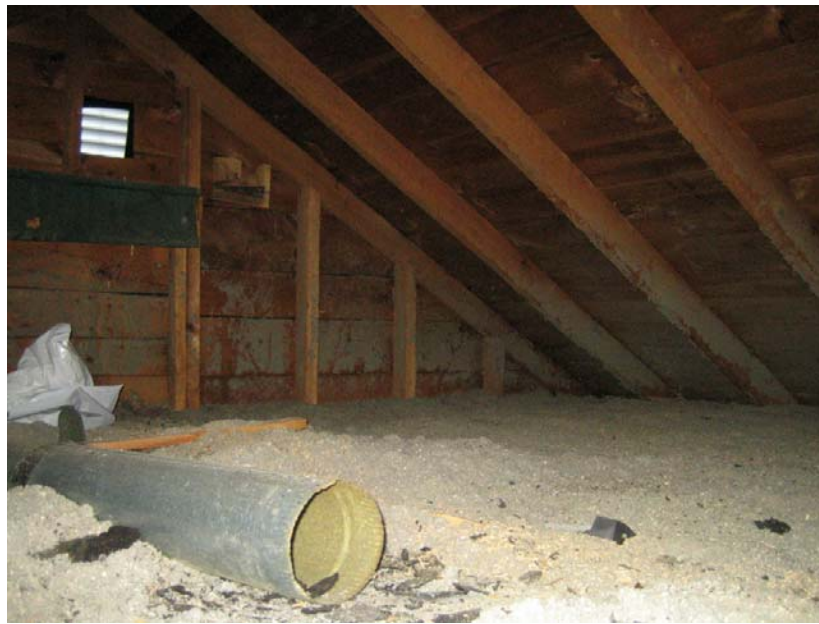
Wall insulation thickness: 4"

R value: ~11

Additional insulation could be added to the attic to reduce heat loss. Blown in cellulose would be recommended, with an R value of around 2.2 per inch of insulation. Fiberglass batting could also be used, and could be installed by the homeowner. Care should be taken not to block the soffit vents, which would restrict air flow in the attic. Additionally, fiberglass batting should be installed above the basement sill plate between the joists in the basement where it is missing.

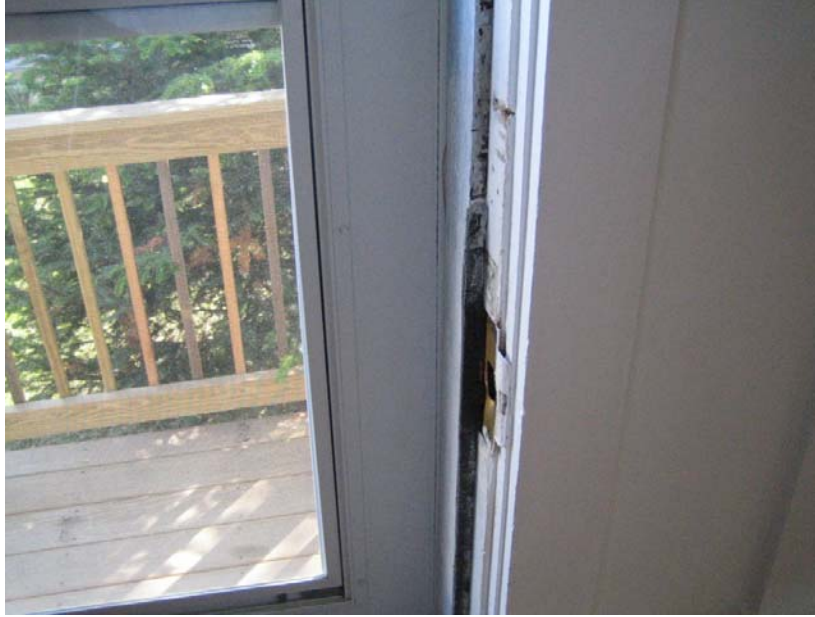
All doors and windows appeared to be in good working condition. The windows are new. The doors are older, but work properly. The weather stripping appeared to be aged and missing in places.

The doors appear to be in good repair and well maintained. With the exception of the door gaskets, no components appear to need replacement at this time. To maintain energy efficiency, it is recommended that the door and window seals be checked every six months to make sure they are not aged, cracked or worn. Replace any seals or gaskets as needed.

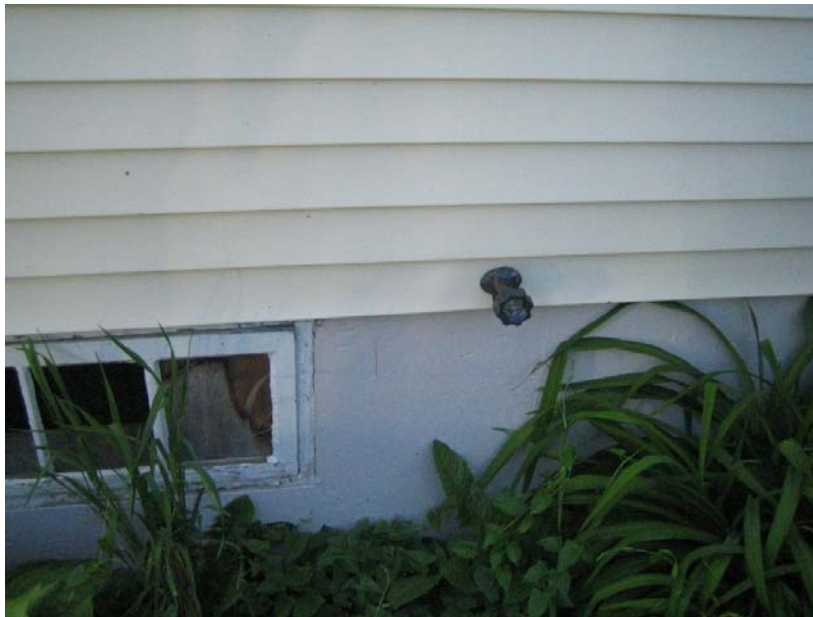
Water piping that was visible appeared to be in good condition, and much of the distribution lines have been recently replaced. The plumbing appears to be working properly. Most of the domestic water supply system has been recently replaced, according to the owner. This is consistent with the observations.

The external hose bibb is the frost free type with an anti-siphon device. Frost free hose bibbs protect against pipes bursting due to cold weather and anti-siphon devices prevent water used in the hoses from backing up into the potable water supply.

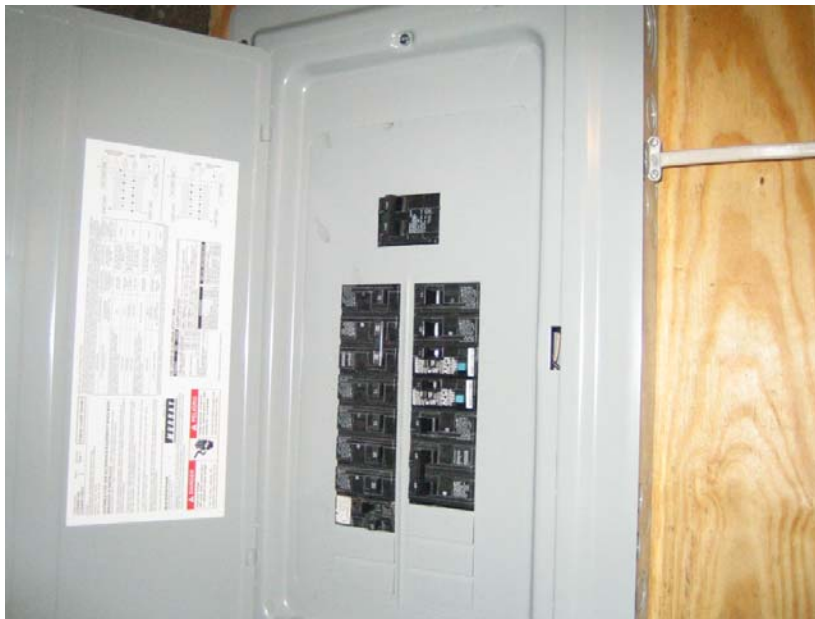
The main distribution panel (MDP) is fed by conductors from the meter. The MDP is a Murray brand panel. It is a new 100 A panel with new breakers.

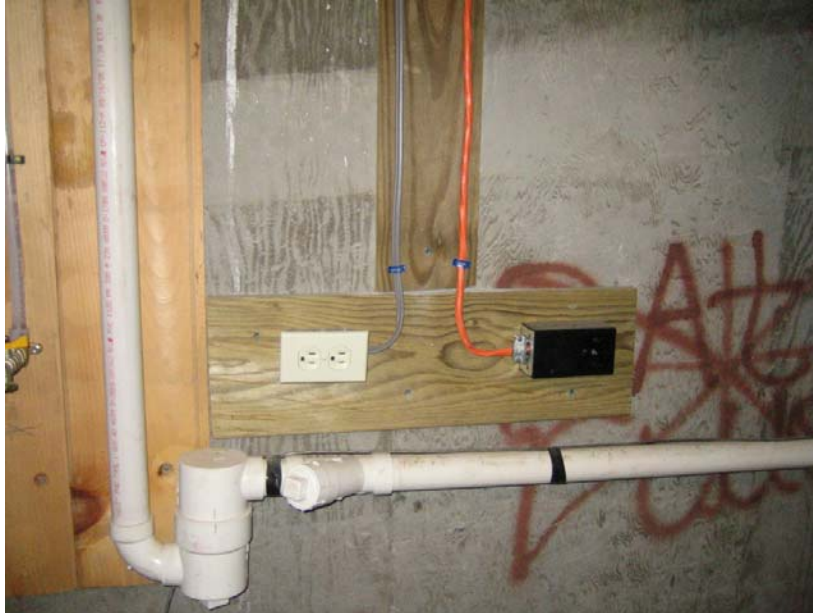
A GFCI were present and tested next to the kitchen sink, and the bathroom sink. However, the outlet for the washing machine was not supplied with a GFCI outlet. Per 2003 IRC E3802.5, unfinished basement receptacles shall have GFCI protection.

Note: Replace existing outlets in the basement with a GFCI outlet.

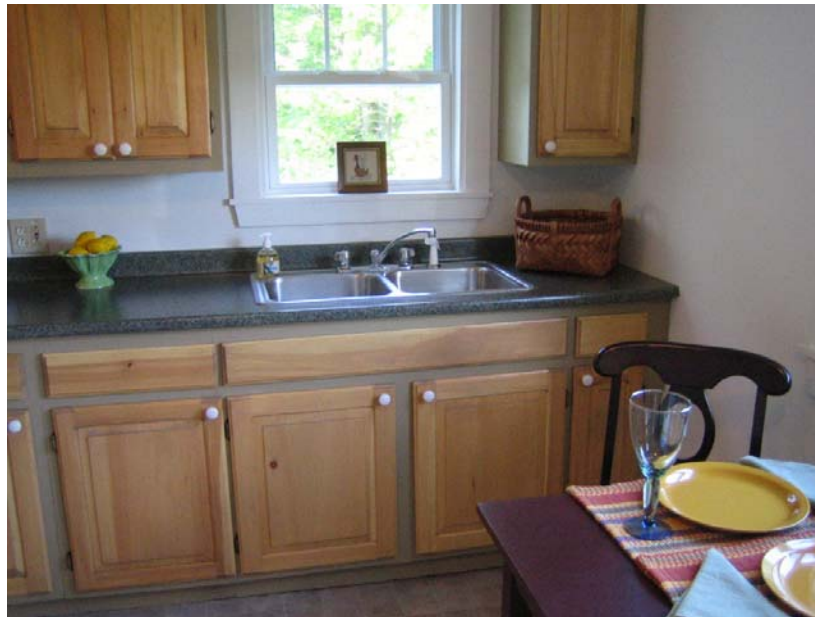
Cabinets and counters appeared to be in good condition, with many new replacements. Doors were hung squarely, and operated properly. Countertops are high pressure laminate on a wood substrate, and are also new.

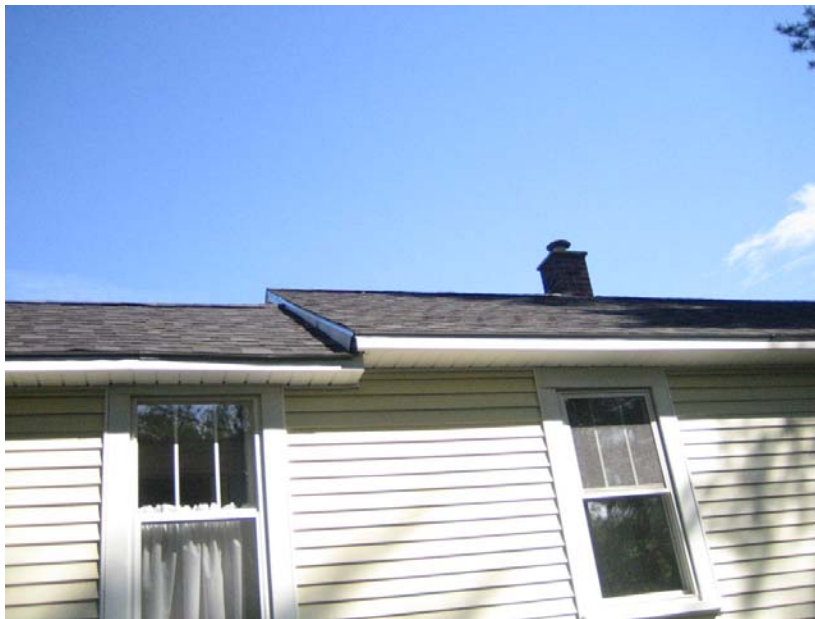
The roof shingles appear to be in good condition. Per the owner, the roof has been recently replaced. No cracked or curling shingles were noted.

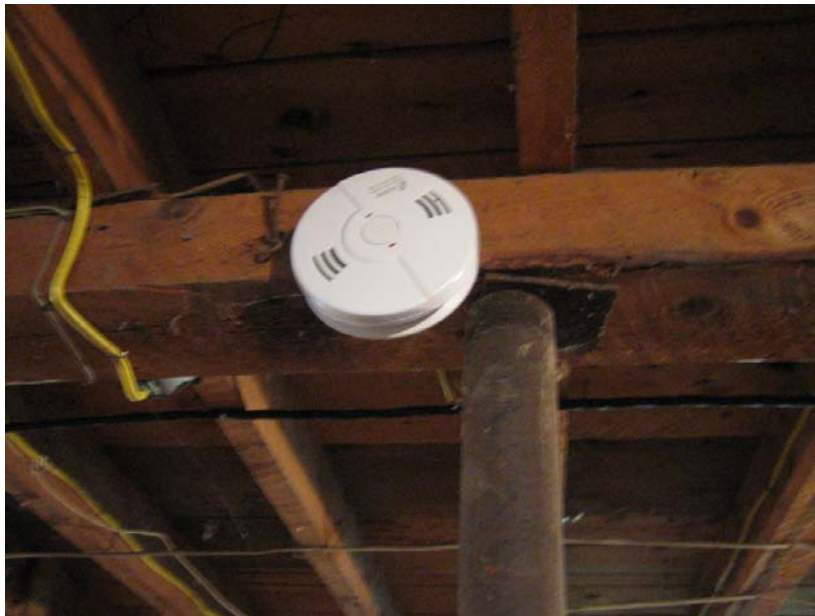
The carbon monoxide detector was located on a floor joist close to the furnace. A smoke detector was not noted.

Recommendation: Install a smoke detector at the top of the stairs. Test smoke detector monthly. Replace batteries annually. Replace non-functional detector as needed.
